**FINAL ENGINEERING REPORT**  
**for the**  
**CITY OF HOLLISTER**  
**HOLLISTER MUNICIPAL AIRPORT**  
**PAVEMENT MANAGMENT SYSTEM**  
**AUGUST 2011**

**KELLEY**  
**ENGINEERING & SURVEYING**

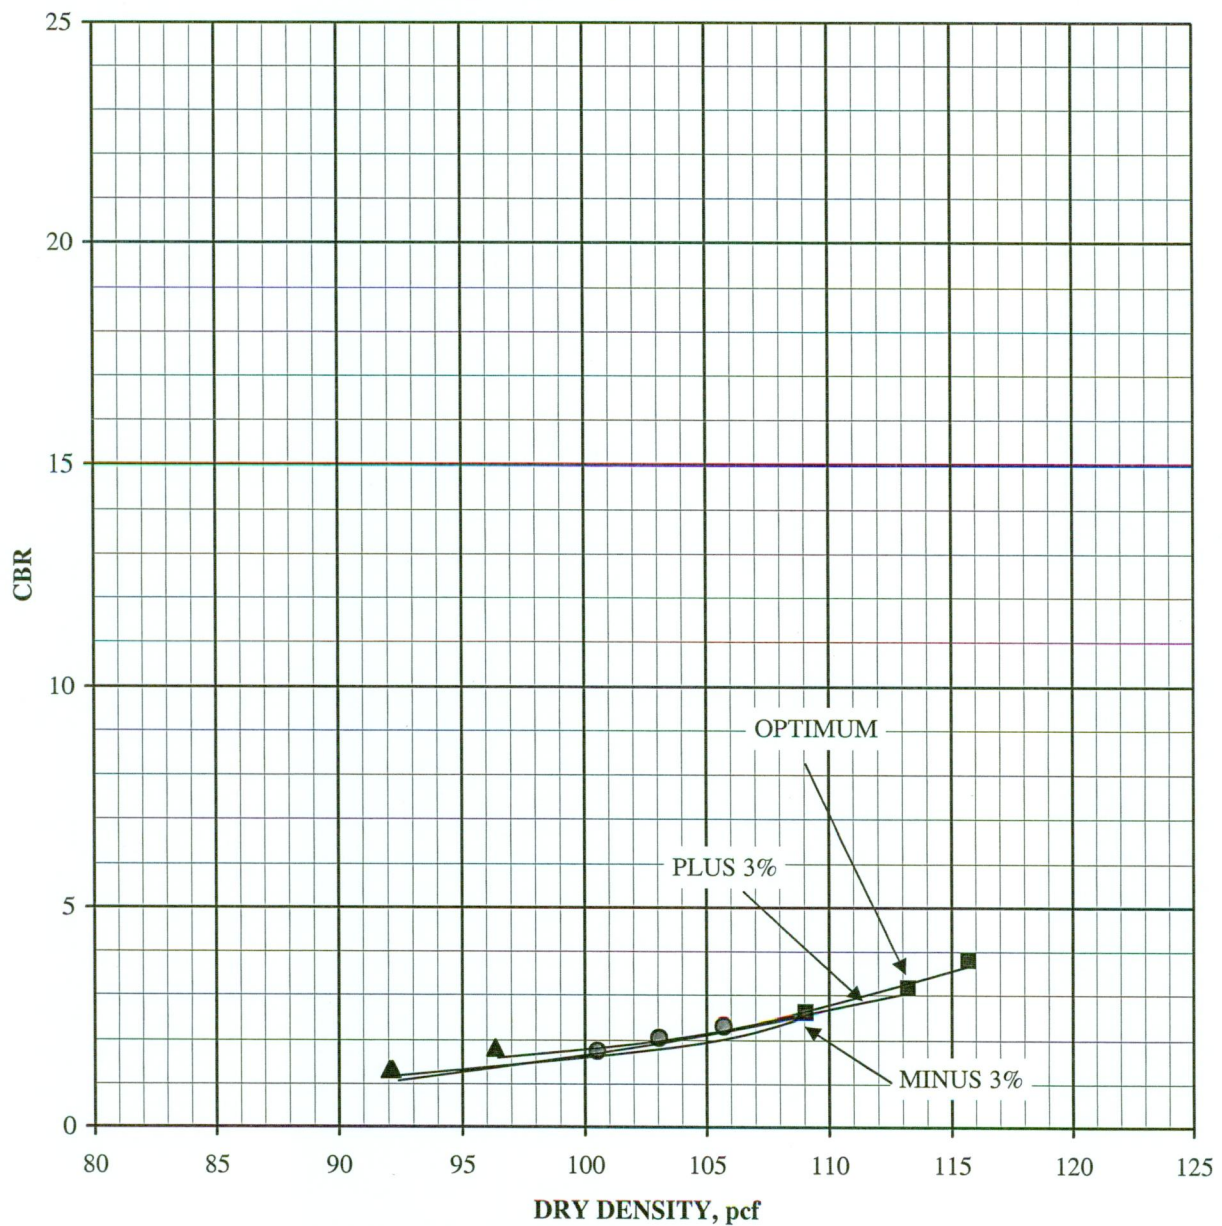
**DRY DENSITY vs. CBR**  
Arranged According to Moisture Content

A California Bearing Ratio (CBR) test was performed on a sample of the combined fat clay with sand subgrade soil. The CBR test is a measure of the mechanical strength of pavement subgrade soil for various soil densities. As shown on the dry density vs. CBR curve included in attached laboratory test results, the maximum CBR for the soil is on the order of 4 at 100 percent of maximum dry density (117.4 pcf) and optimum moisture content (12.1 percent). The CBR test results at lower dry densities and higher and lower moisture contents indicate that the CBR decreases as expected with reduced soil densities and moisture contents other than optimum. Although CBR tests were not performed at the in-situ moistures and densities, from the test results it is apparent that the CBR of the subgrade soils at their existing moisture contents and densities would be 1 or less.

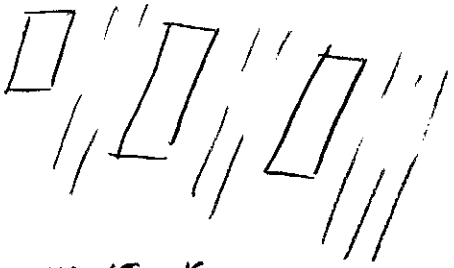
| AIRFIELD ASPHALT PAVEMENT CONDITION SURVEY DATA SHEET | | | | | | | |
|---|---|---|---|---|---|---|---|
| | L | M | H | <p>ALL CRACKING IS IN OLD SECTIONS<br/>NEW SECTIONS NO DISTRESS<br/>VALLEY CUTTERS ARE IN GOOD CONDITION</p> | | | |
